# Inspector General

Army's Management of the Operations and Support Phase of the Acquisition Process for Body Armor

| maintaining the data needed, and c including suggestions for reducing | lection of information is estimated to<br>ompleting and reviewing the collect<br>this burden, to Washington Headqu<br>uld be aware that notwithstanding an<br>DMB control number. | ion of information. Send comment<br>arters Services, Directorate for Info | s regarding this burden estimate<br>ormation Operations and Reports | or any other aspect of the s, 1215 Jefferson Davis | nis collection of information,<br>Highway, Suite 1204, Arlington |
|--|---|---|---|--|--|
| 1. REPORT DATE <b>08 DEC 2009</b> | | 2. REPORT TYPE | | 3. DATES COVE<br>00-00-2009 | red<br>To 00-00-2009 |

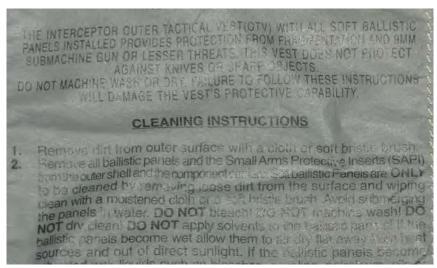
Figure 7. Label Inside the Vest

Army officials at 3 of the 14 sites we visited were not cleaning the IOTV or OTV in accordance with applicable guidance. Instead, Army officials were machine washing and drying the vests, which may cause deterioration and fading. The Use and Care Manual, the Technical Manual, and the vests themselves state that the IOTV and OTV must be hand washed only and may not be machine washed or dry cleaned (Figure 7). Additionally, the Use and Care Manuals and the Technical Manual further state that vests must be hand washed in lukewarm water with a mild detergent and may not be washed with yellow soap, detergent, or bleach because those cleaners may fade or deteriorate the vests.

Army officials at the Joint Personnel Effects Depot, Fort Bragg, and Camp Ali Al Salem, Kuwait, were machine washing and drying the IOTV and OTV. Officials at the Joint Personal Effects Depot and Camp Ali Al Salem stated they were unaware that the vests should be hand washed. Fort Bragg officials stated that they were aware of the hand washing requirement, but would continue to machine wash and dry the IOTV because they believe that their contractor adequately cleans the vests without damage. Because machine washing the IOTV and OTV may cause deterioration and fading (Figures 8 and 9), it is essential that IBA users comply with cleaning instructions. Improper cleaning could decrease the life expectancy of the vests and render them useless against ballistic threats.
